NEARSHORE CURRENTS AND CORAL REEF  
ECOLOGY OF THE WEST COAST OF GUAM,  
MARIANA ISLANDS

3. REPORT TITLE  NEARSHORE CURRENTS AND CORAL REEF ECOLOGY OF THE WEST COAST OF GUAM, MARIANA ISLANDS			
4. DESCRIPTIVE NOTES (Type of report and inclusive dates) Technical Report. 4 Feb. - 3 Mar. 1971 and 19 Aug. - 15 Sept. 1971

SPECIAL PUBLICATION

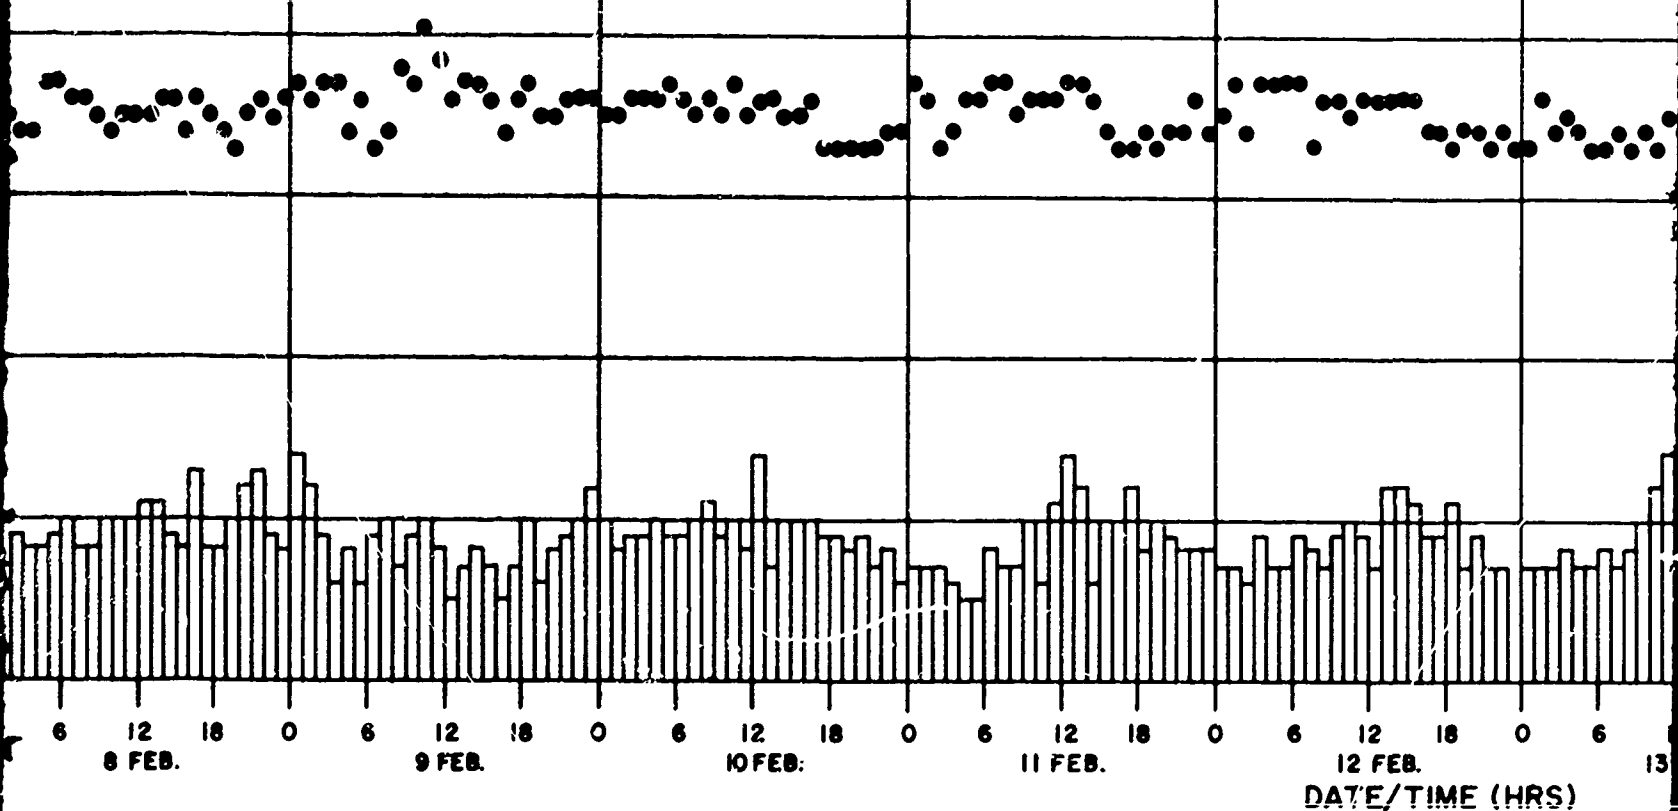
Figure 2. Speed and direction of winds observed at the Naval Air Station during the two periods and dye and drogue observation dates for the two flights.

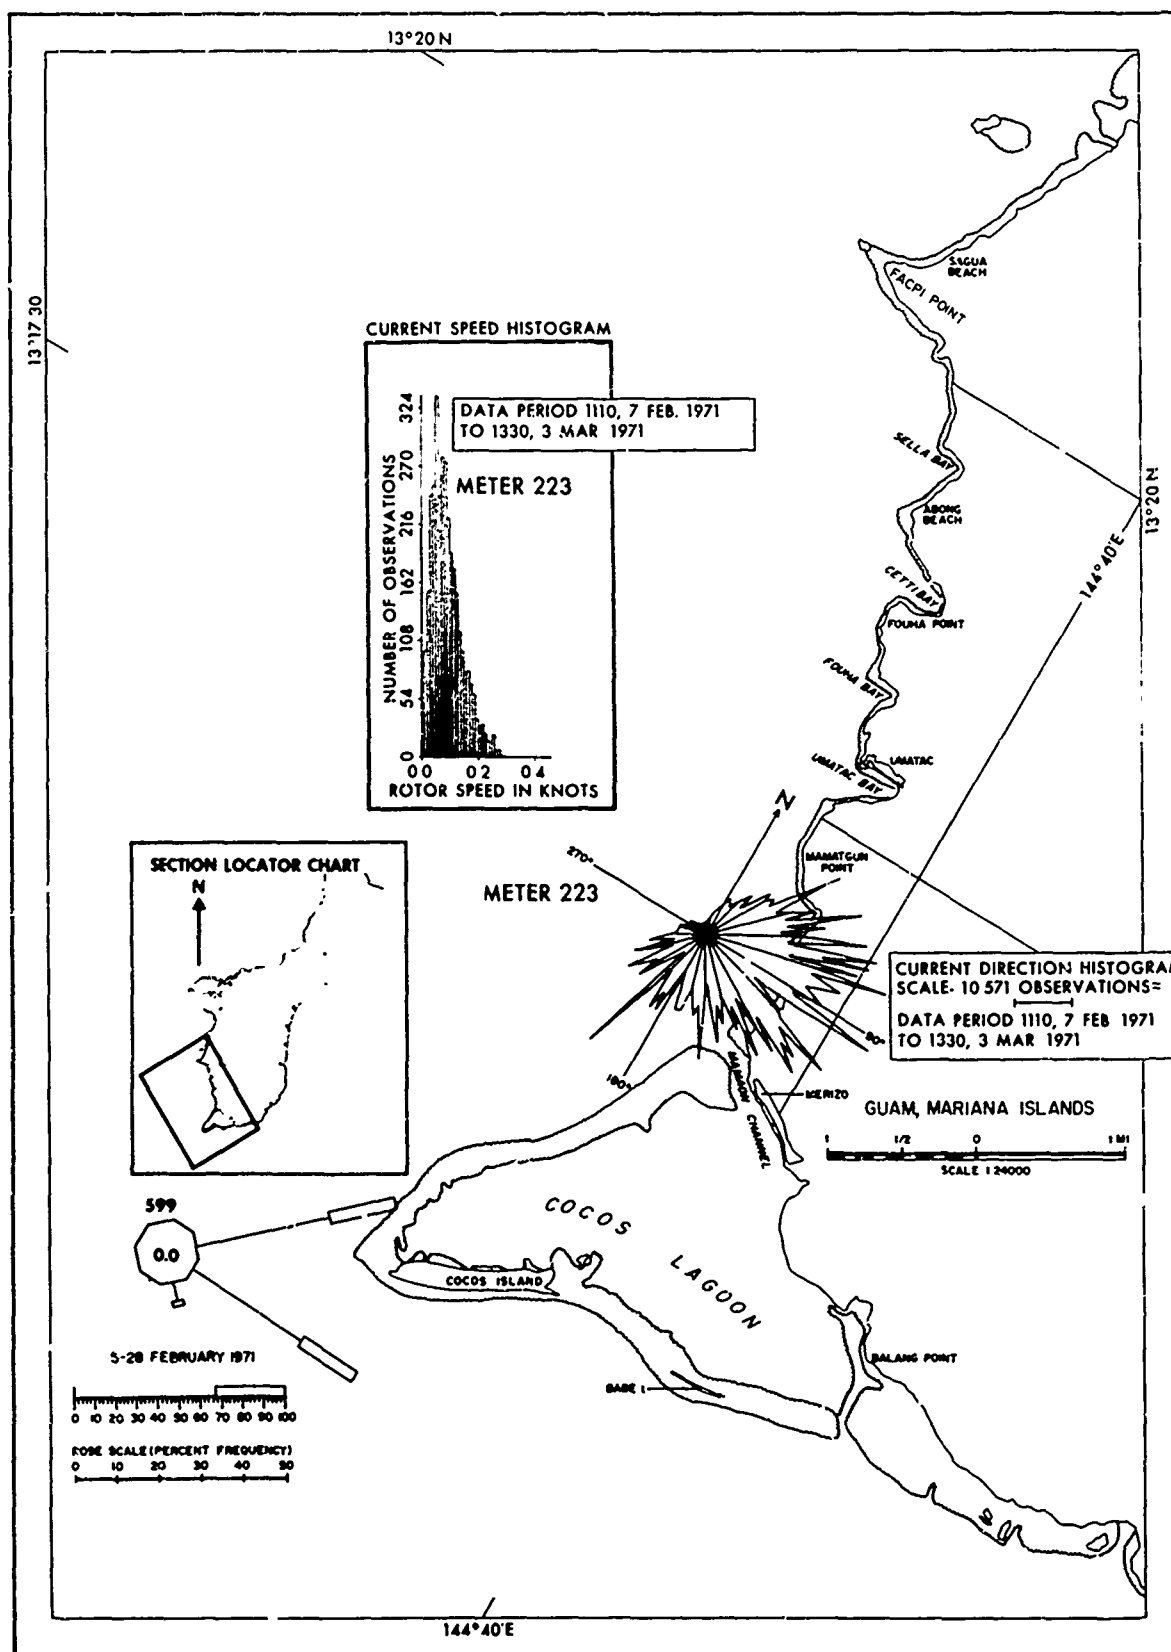
Figure 4. Current speed histogram and current direction histogram for the Bile Section in winter including meter #223 and a wind rose for the data period.

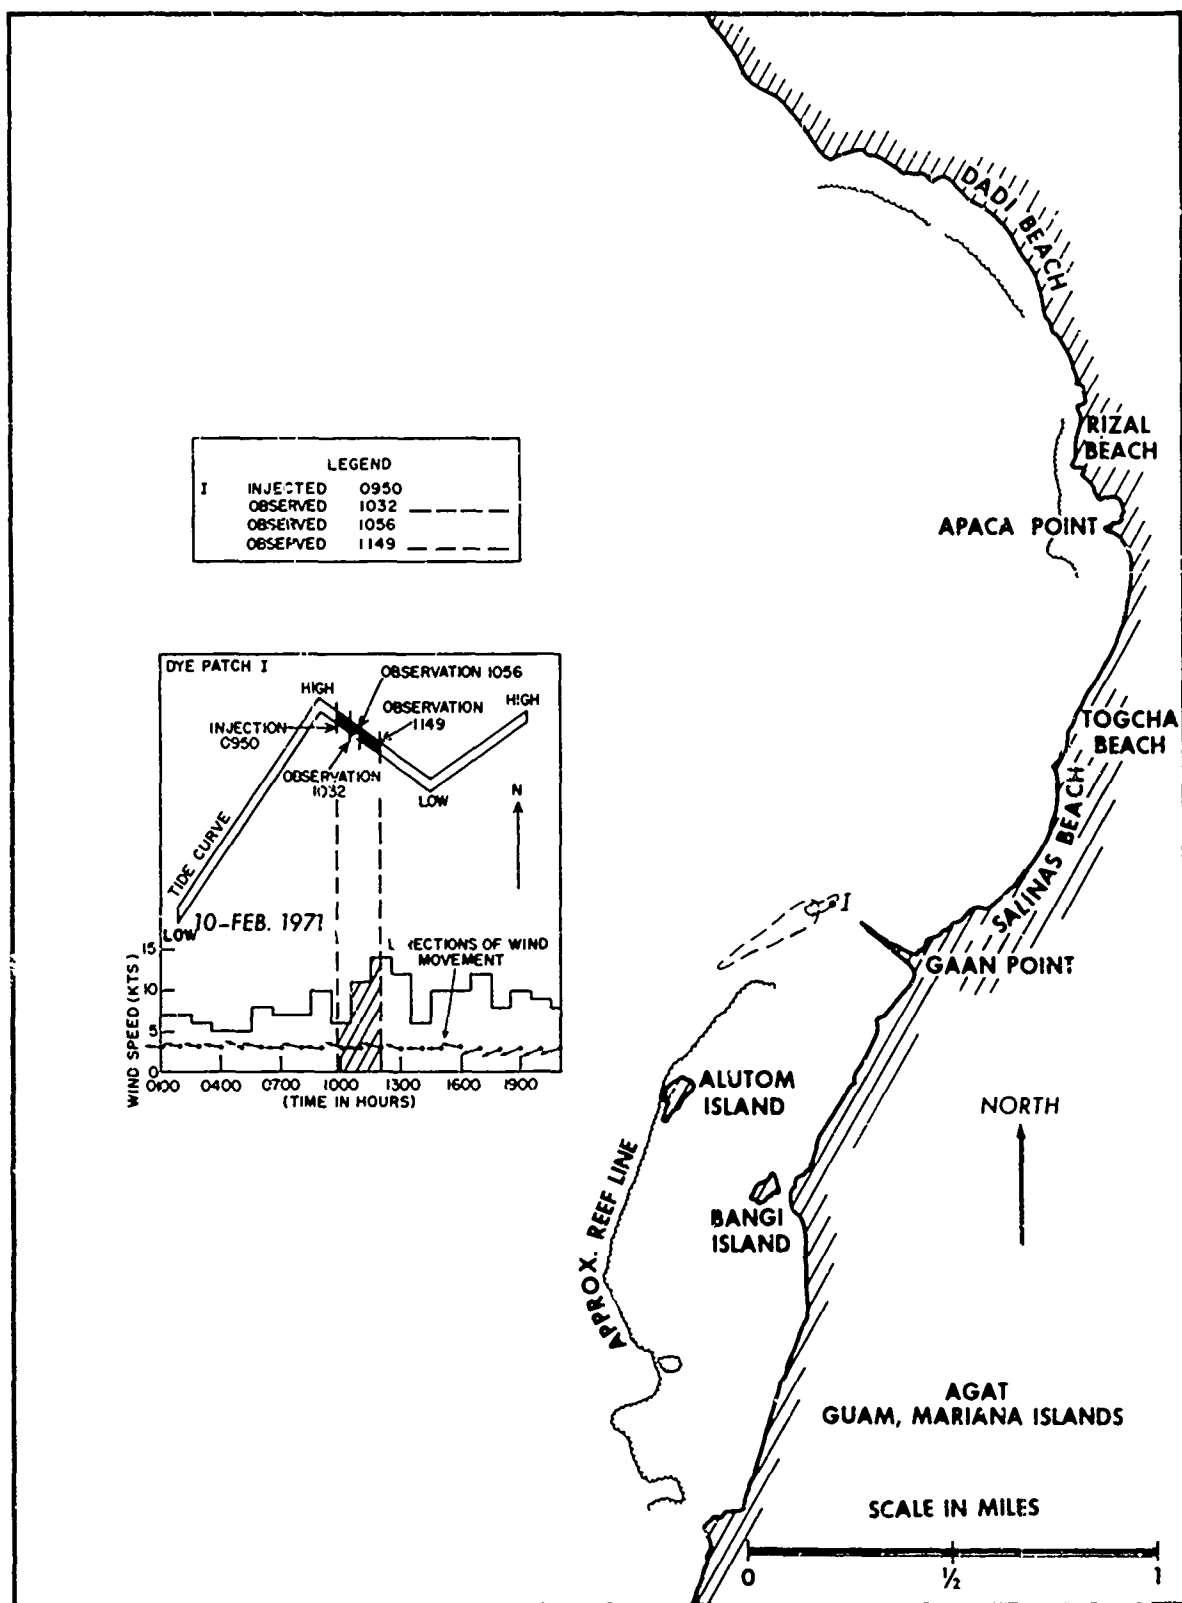
Figure 37. Dye movement at Agat Bay on 10 February 1971, A.M.

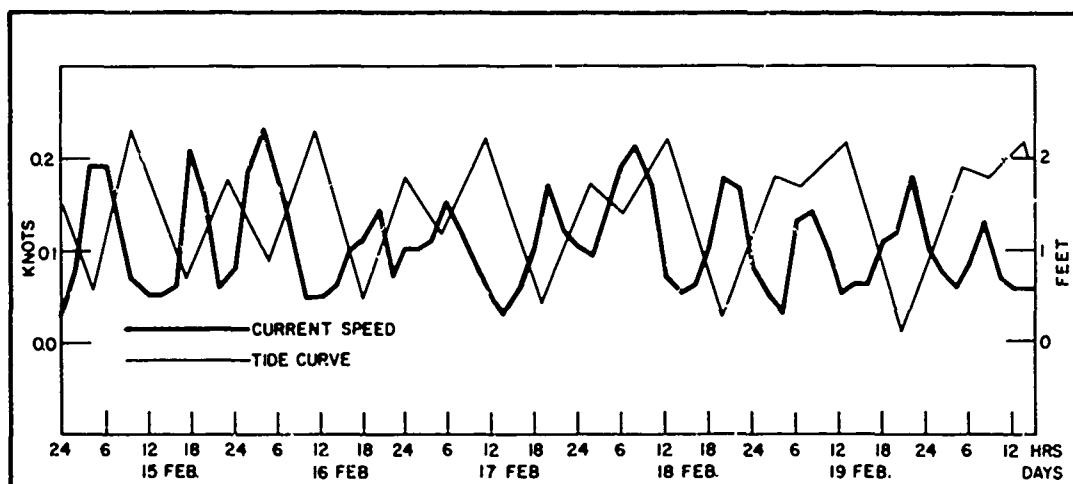
Figure 47. Current speeds versus tides from meter #323, 0000, 15 February to 1400, 20 February 1971.

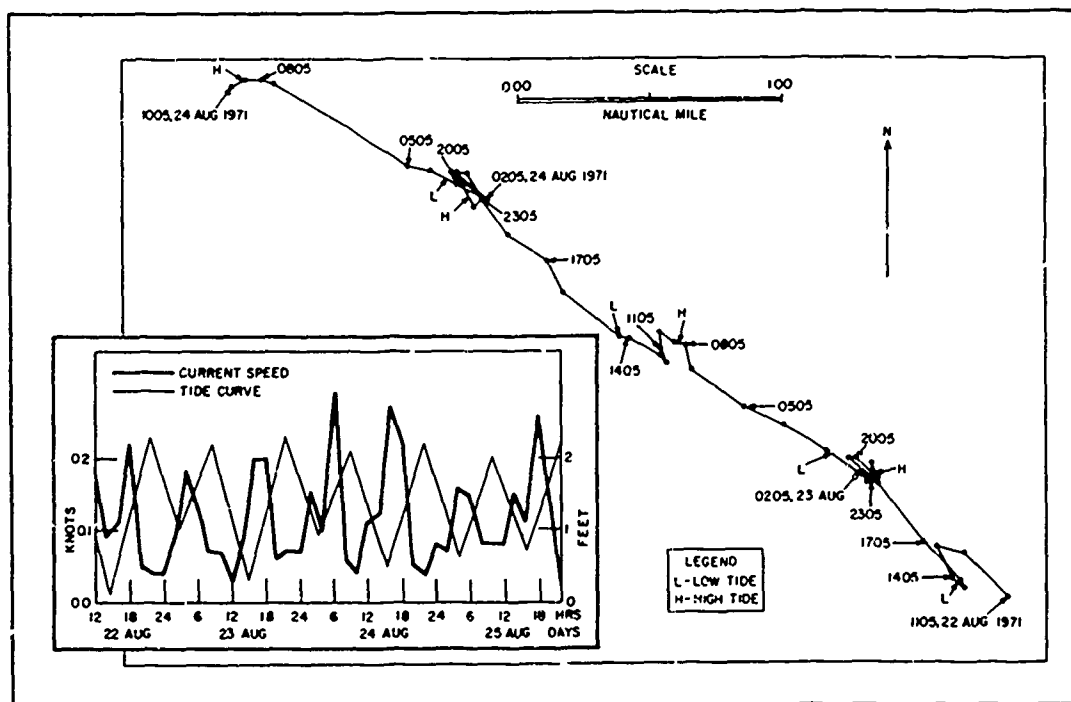
Figure 49. Progressive vector diagram of current from meter #429, 1105, 22 August to 1005, 24 August 1971, and current speeds versus tides from 1200, 22 August to 2000, 25 August 1971.

A similar situation existed during the summer field survey as shown in the data from meter #429 (figs. 36 and 49). Peak speeds occurred during rising tide and lower speeds were recorded during ebb. Speeds were generally higher during the summer, reaching a maximum of 0.55 knot (.275 m/sec). Currents flowed northwest during flood and were variably southeast and northwest during ebb.

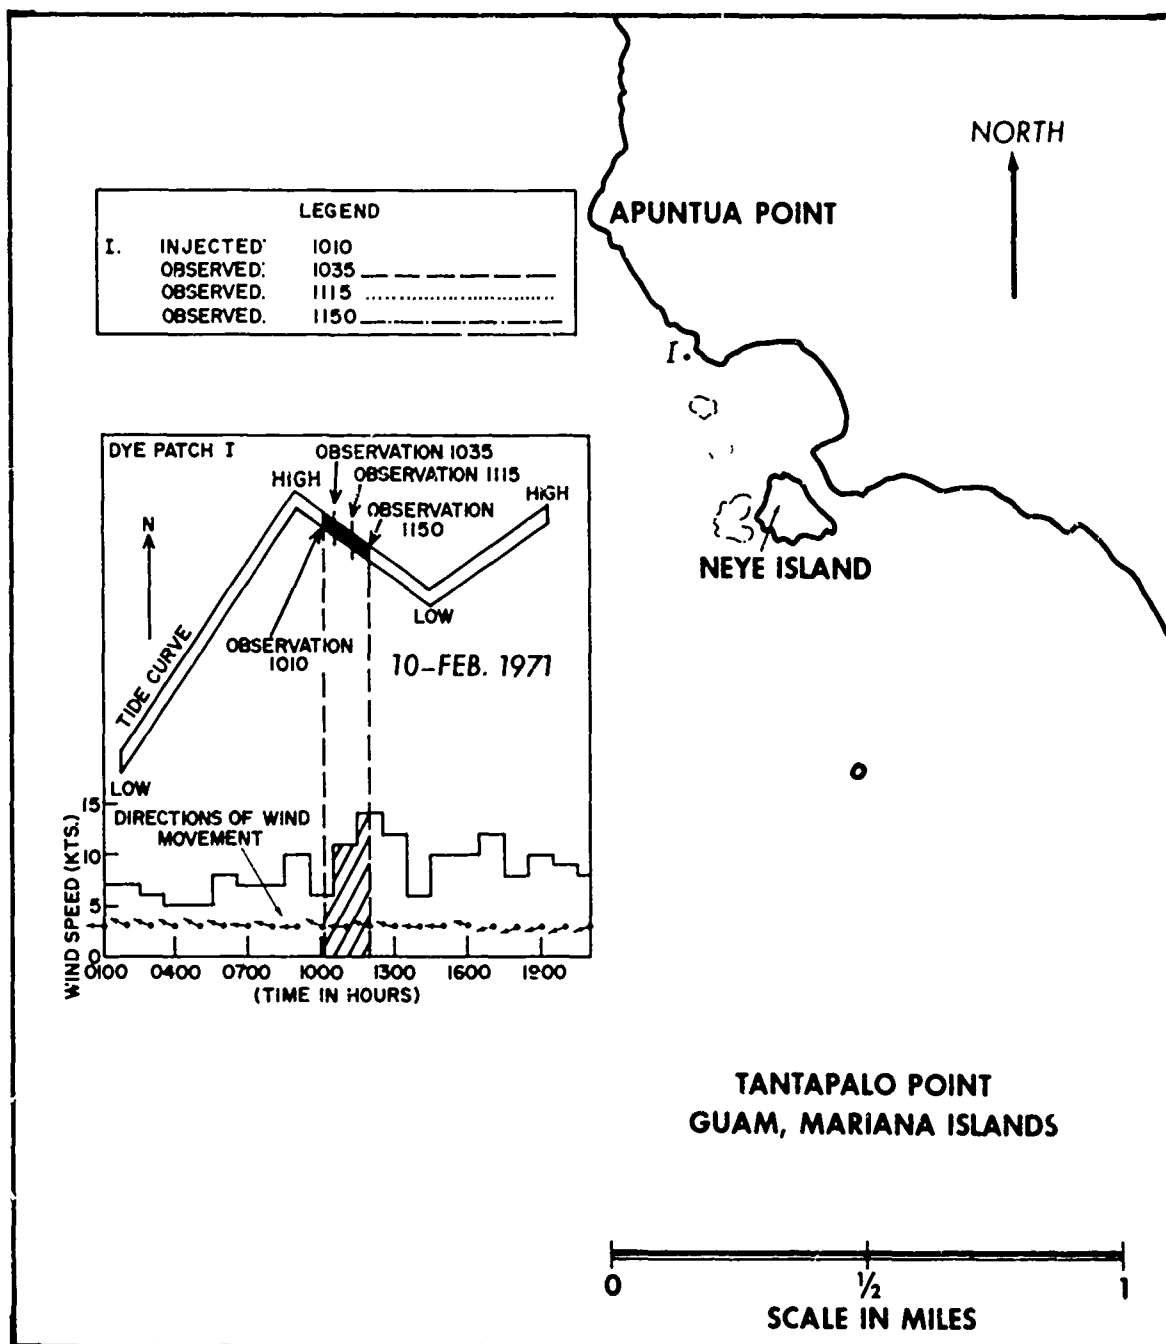
Figure 50. Dye movement at Tantapalo Point on 10 February 1971, A.M.

Two dye patches were tracked off Tantapalo Point on 10 February (figs. 50 and 51) and an aerial photograph was taken of the sewage effluent on 26 February (fig. 52). Dye and sewage movements confirmed the general pattern shown by the current meter data. Four dye injections were made off Dadi Beach during August and September (figs. 42 through 45). Three of these were observed during the falling tide and showed sluggish eddying currents. One dye patch, observed during flood, was subject to a relatively strong current setting to the south (fig. 42). This southerly flow during flood was exactly opposite to the general pattern at Tantapalo Point and illustrates the eddying nature of the currents in Agat Bay.

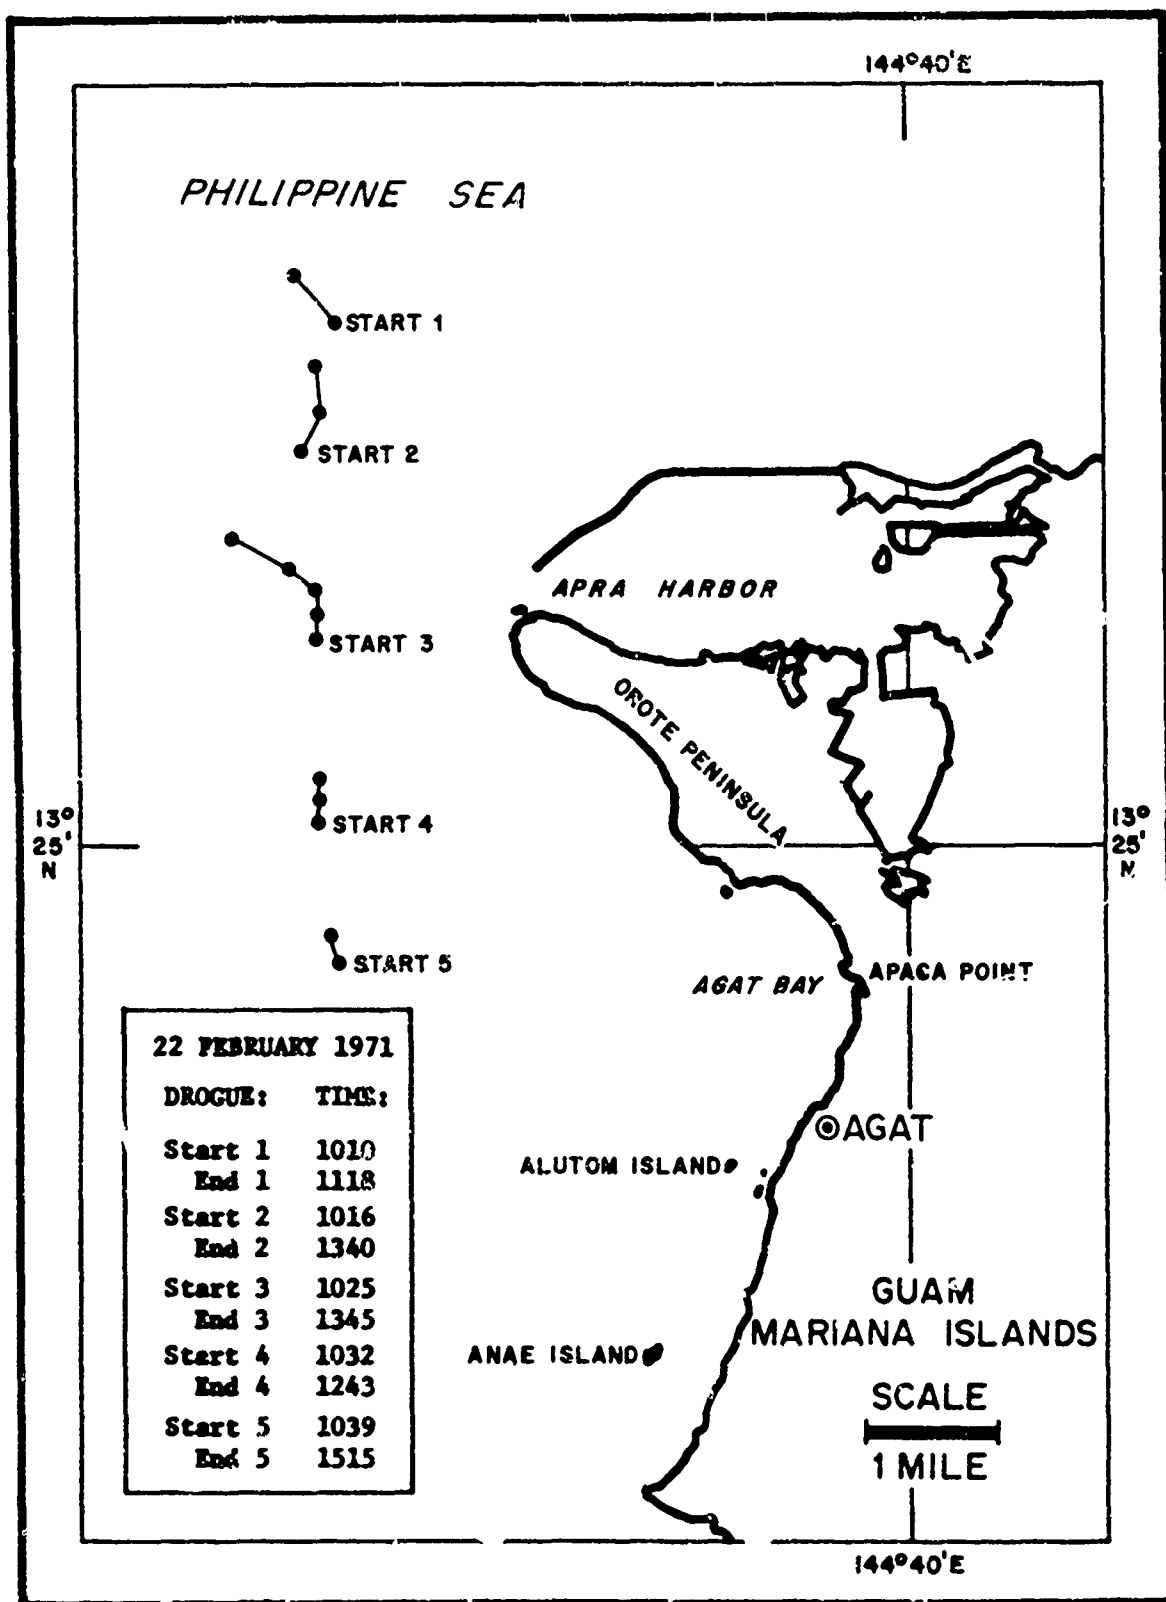
Figure 55. Drogue observations in Agat Section, 22 February 1971.

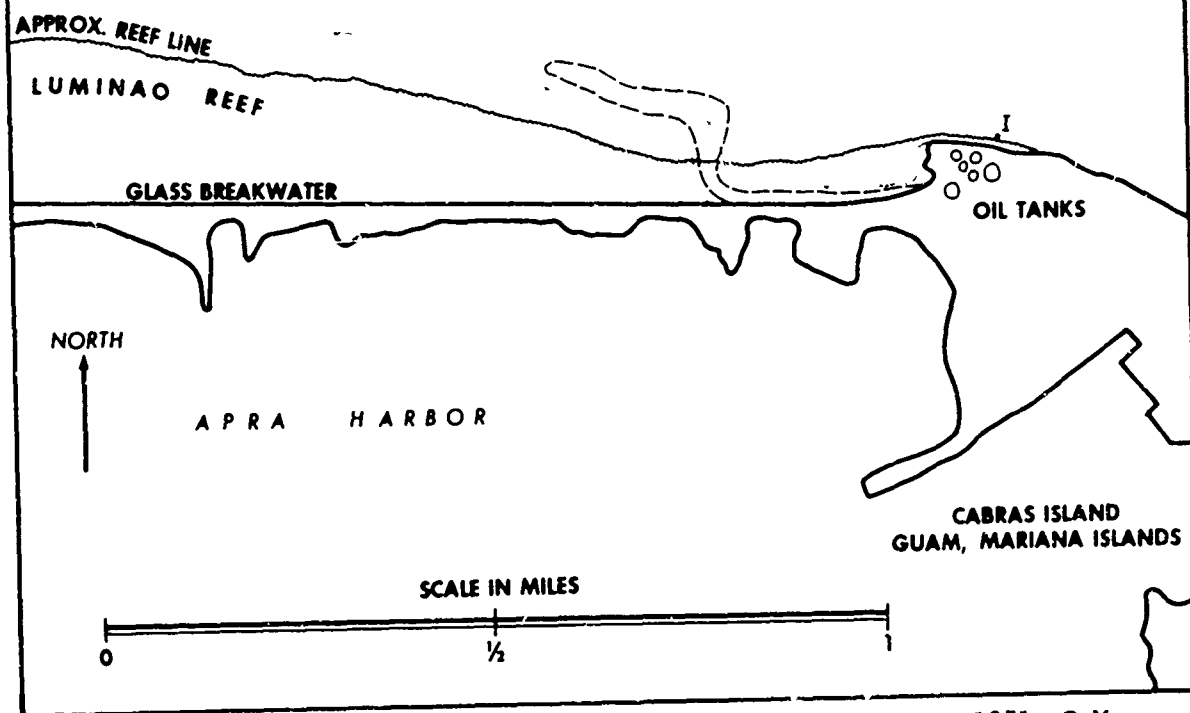
Figure 67. Dye movement at Cabras Island on 26 February 1971, P.M.

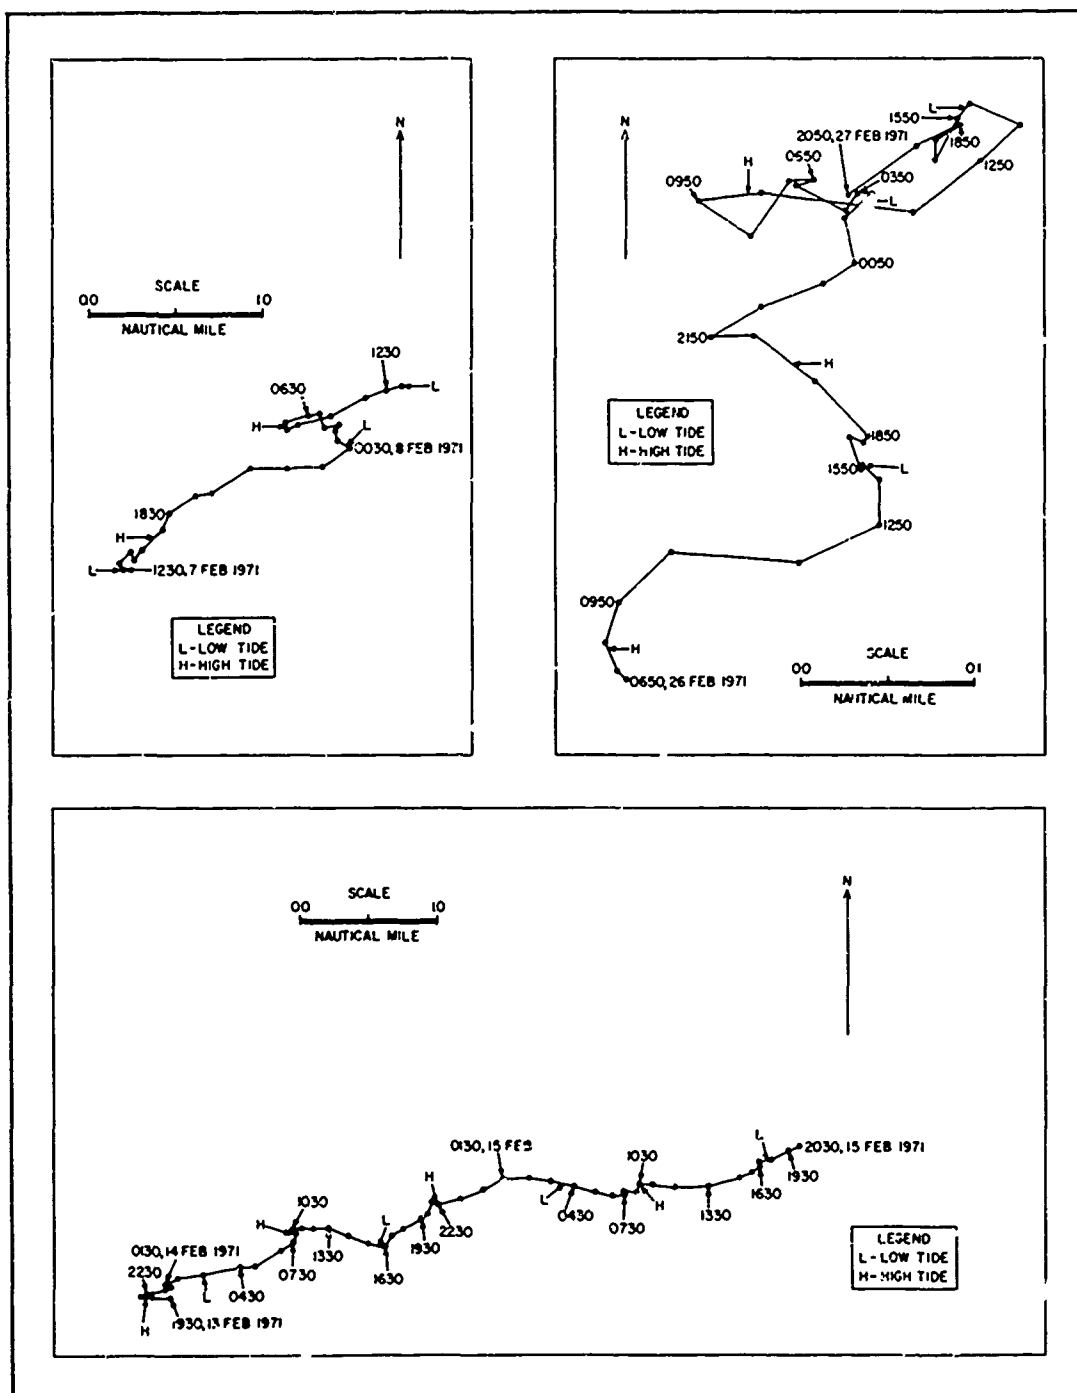
Figure 76. Progressive vector diagrams of current from meter #103, 1230, 7 February to 1330, 8 February; 0650, 26 February to 2050, 27 February; and 1930, 13 February to 2030, 15 February 1971.

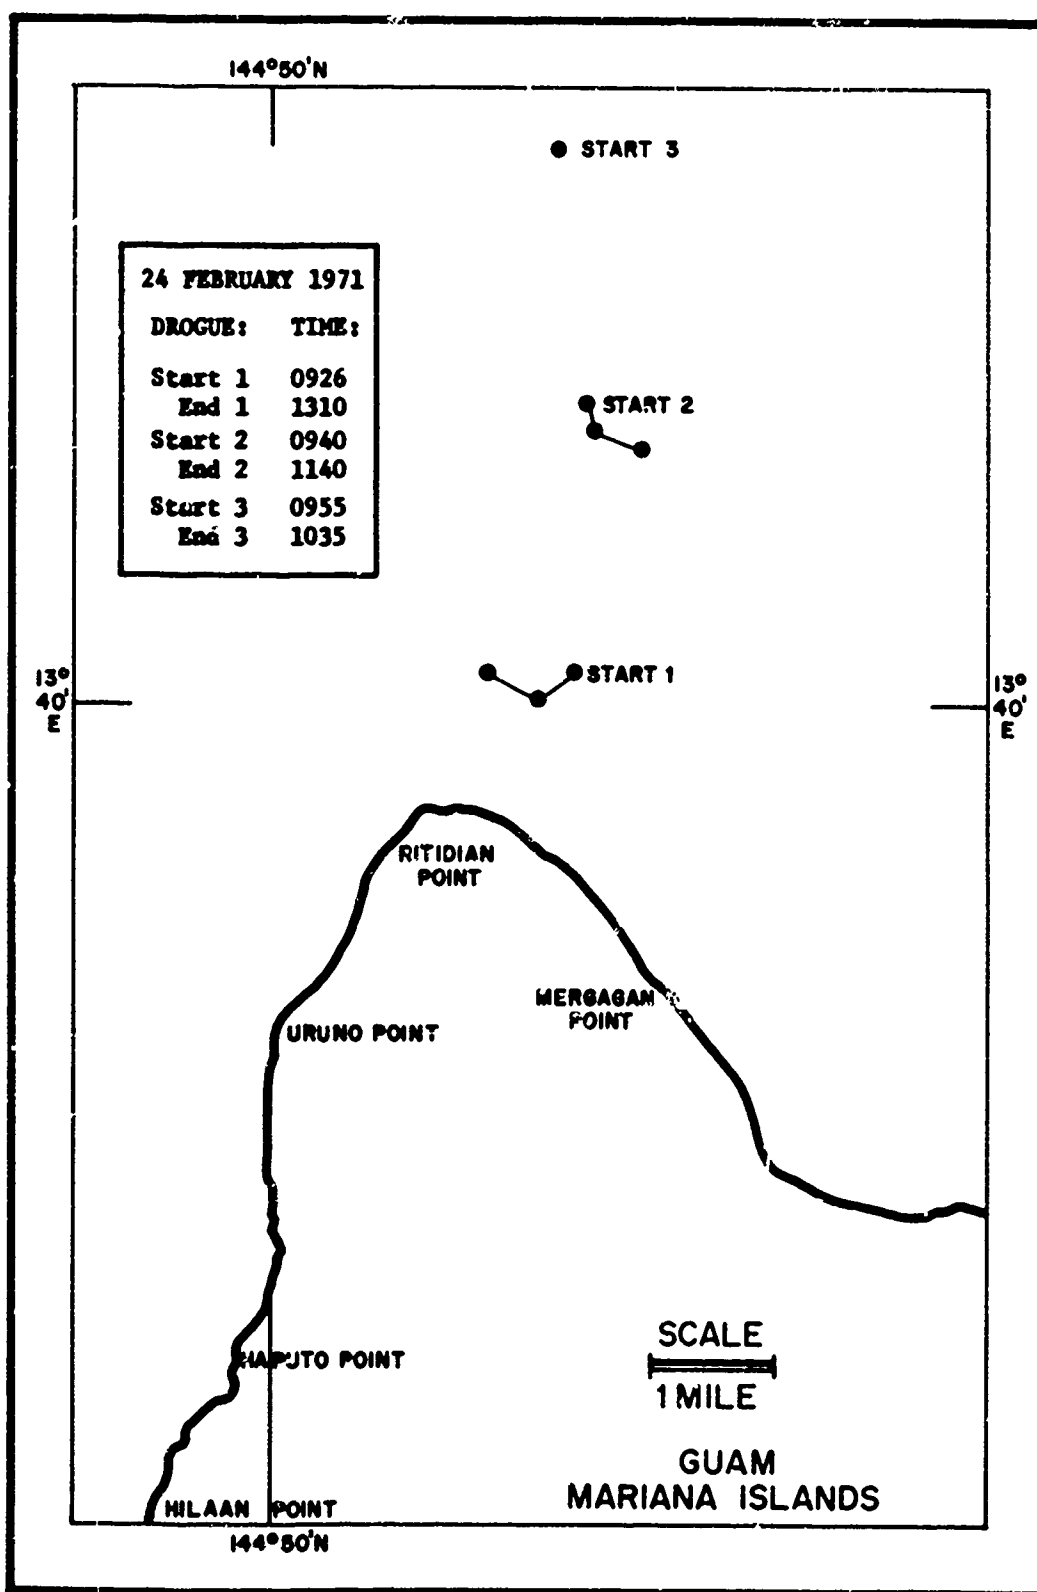
Figure 111. Drogue observations in Ritidian Section, 24 February 1971.

Surface drogues were tracked north of Ritidian Point during February and August (figures 111 and 112). During February surface currents appeared to be relatively weaker; no movement at all was observed 5 miles (8 km) north of the point. Currents within a mile of Ritidian Point showed a more easterly component during both winter and summer than the currents further from shore.

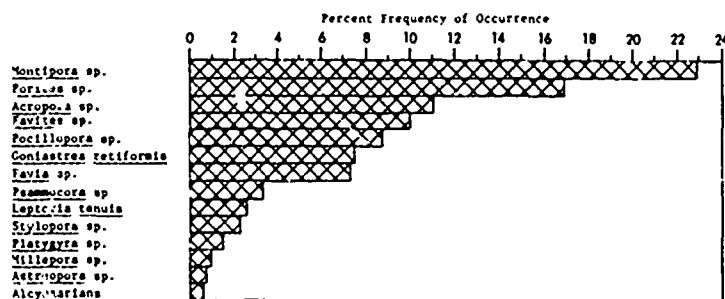
Figure 113. Frequency of occurrence of coral in quadrats on the first terrace of the reef front (quadrats 1 and 3).

Figure 113 is a composite frequency histogram of corals in quadrats 1 and 3 located on the first terrace, and figure 114 is a composite frequency histogram of corals in quadrats 2, 4, and 5 located on the slope to the second terrace.

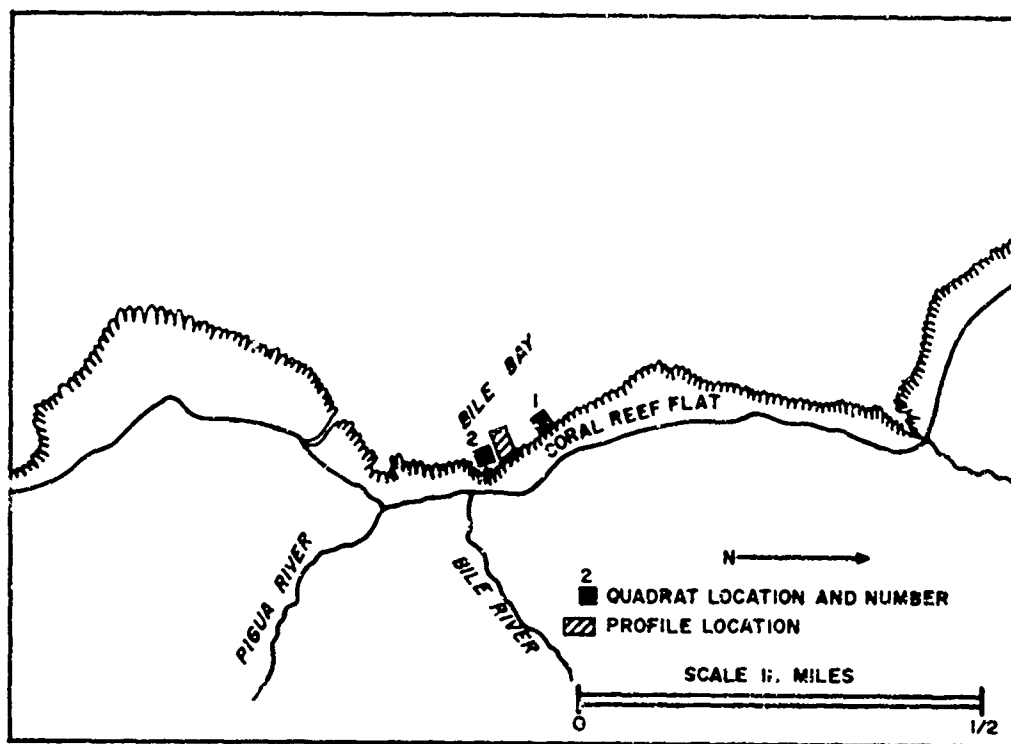
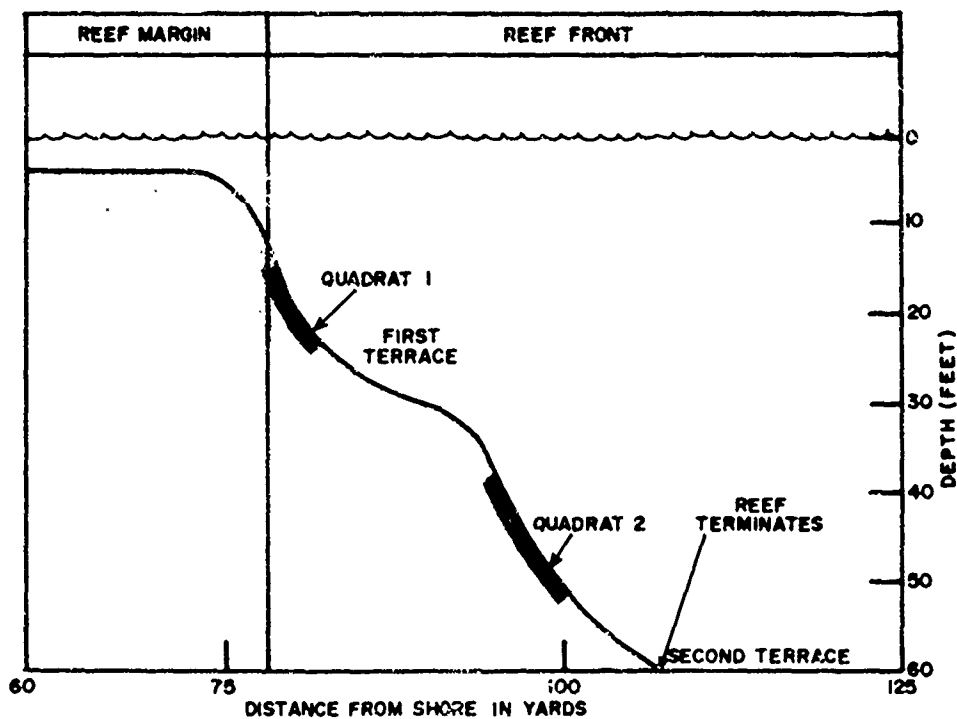
Figure 115. Area chart and reef profile for Bile Bay ecological study.

Bile Bay lies in a protected location on the southwestern coast of the island. Sheltered inland by mountains and facing southwest, the bay receives few strong winds and is not subject to strong currents. Two streams, the Bile and Pigua, empty into the bay and physically divide it into three parts. Both streams flow through sparsely populated regions, and they are used by inhabitants for some waste removal. The streams are generally low volume; however, after heavy rains large sediment plumes extend into the bay. The streams have caused an impact sufficient to inhibit coral growth in their direct path of flow, and in adjacent areas they restrict coral growth to genera with some tolerance to silting. Figure 115 presents a profile and chart of the Bile Bay ecological study area.

The reef at Bile Bay is a narrow fringe 110 yards (100.6 meters) wide. The reef begins at the shore vegetation line and at its seaward limit it meets a sand and silt bottom at the 60-foot (18.3-meter) depth. The reef of the bay center, modified by the outflow of the streams, is narrow and broken by channels; whereas, the reef at each end of the bay is broader and more uniform.

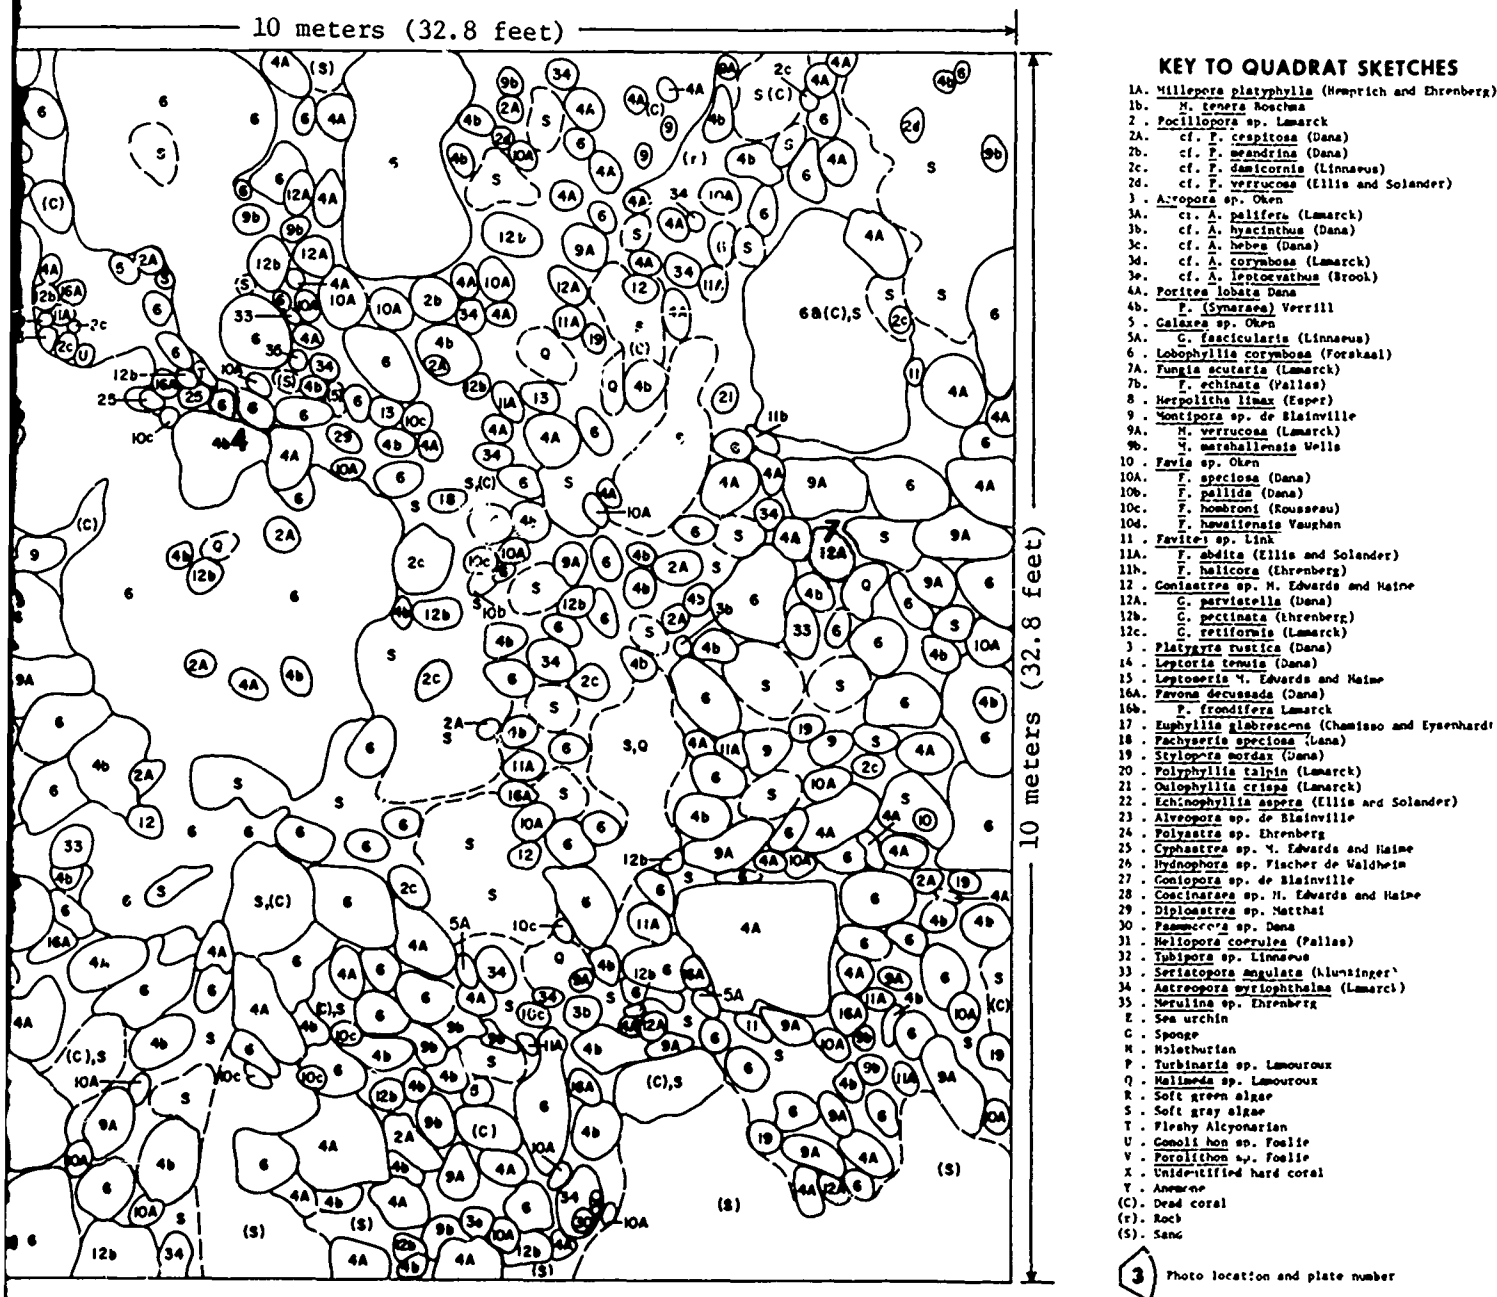
Figure 118. Species distribution chart, quadrat 2, Bile Bay.

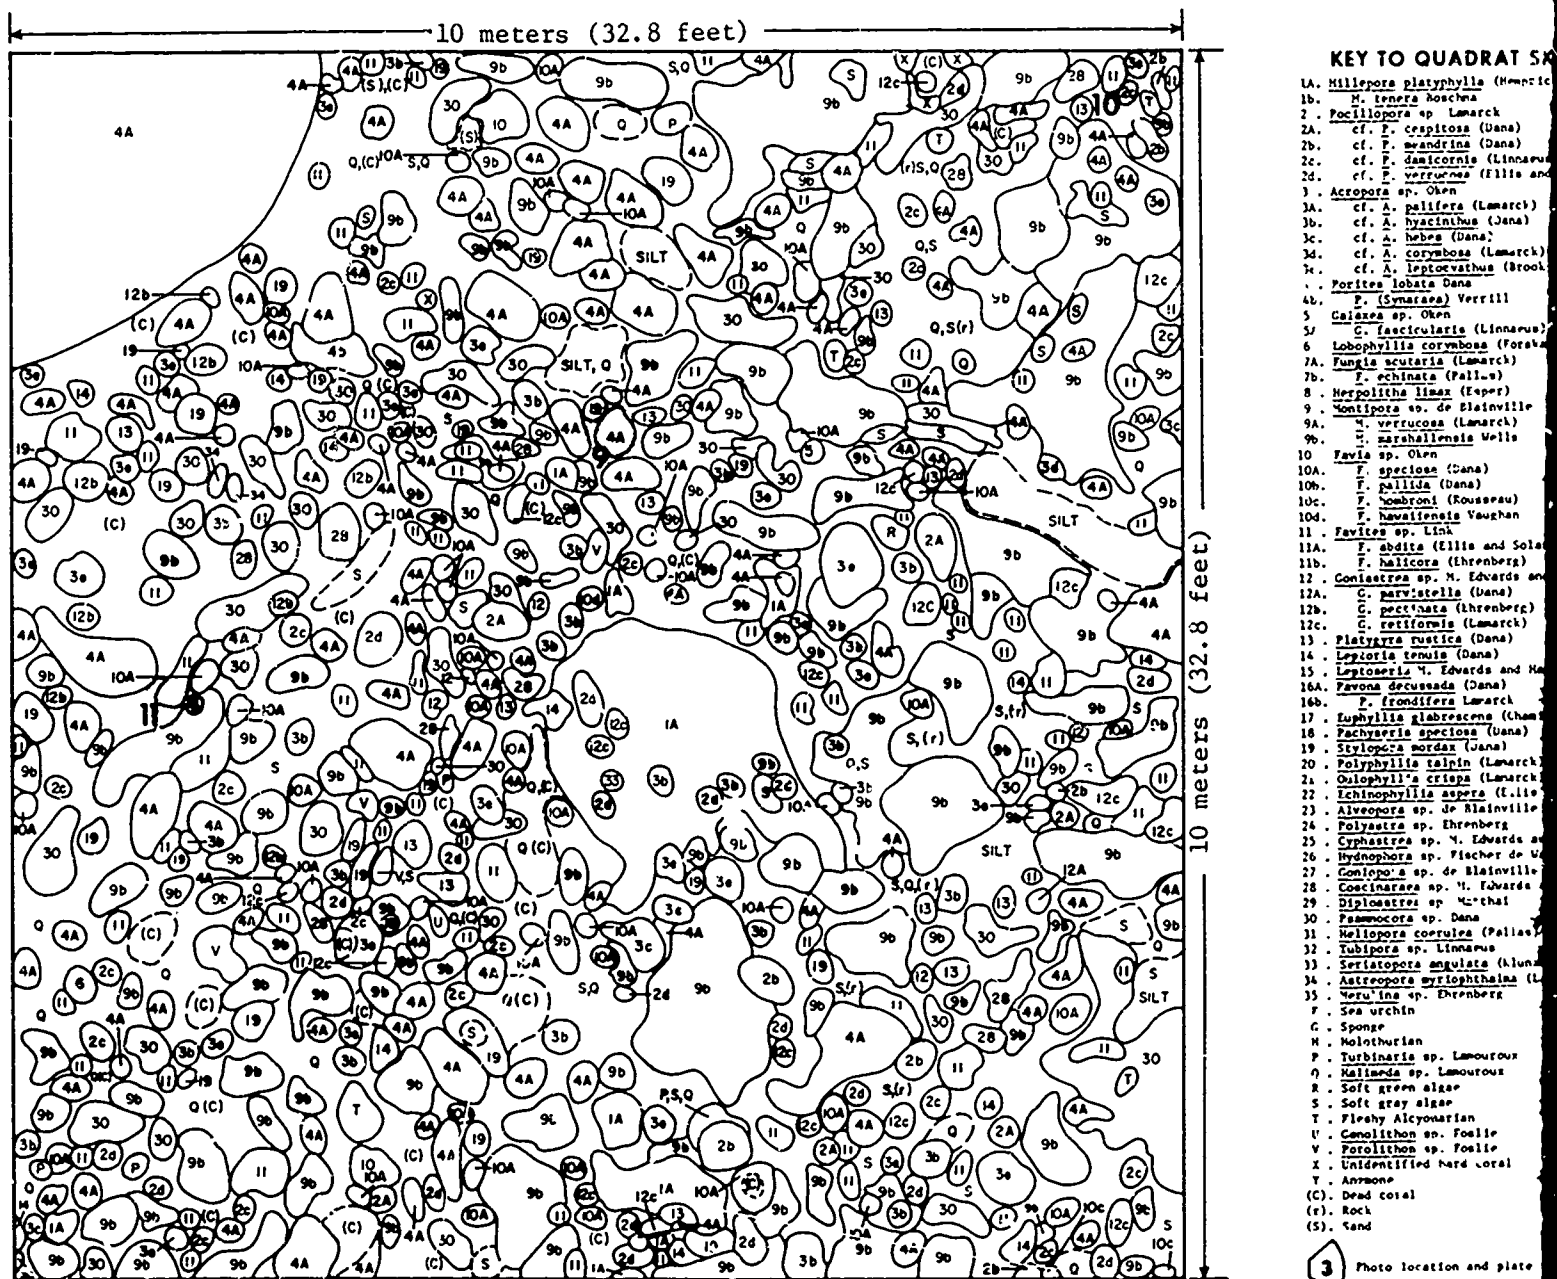
Figure 121. Species distribution chart, quadrat 3, Sella Bay.

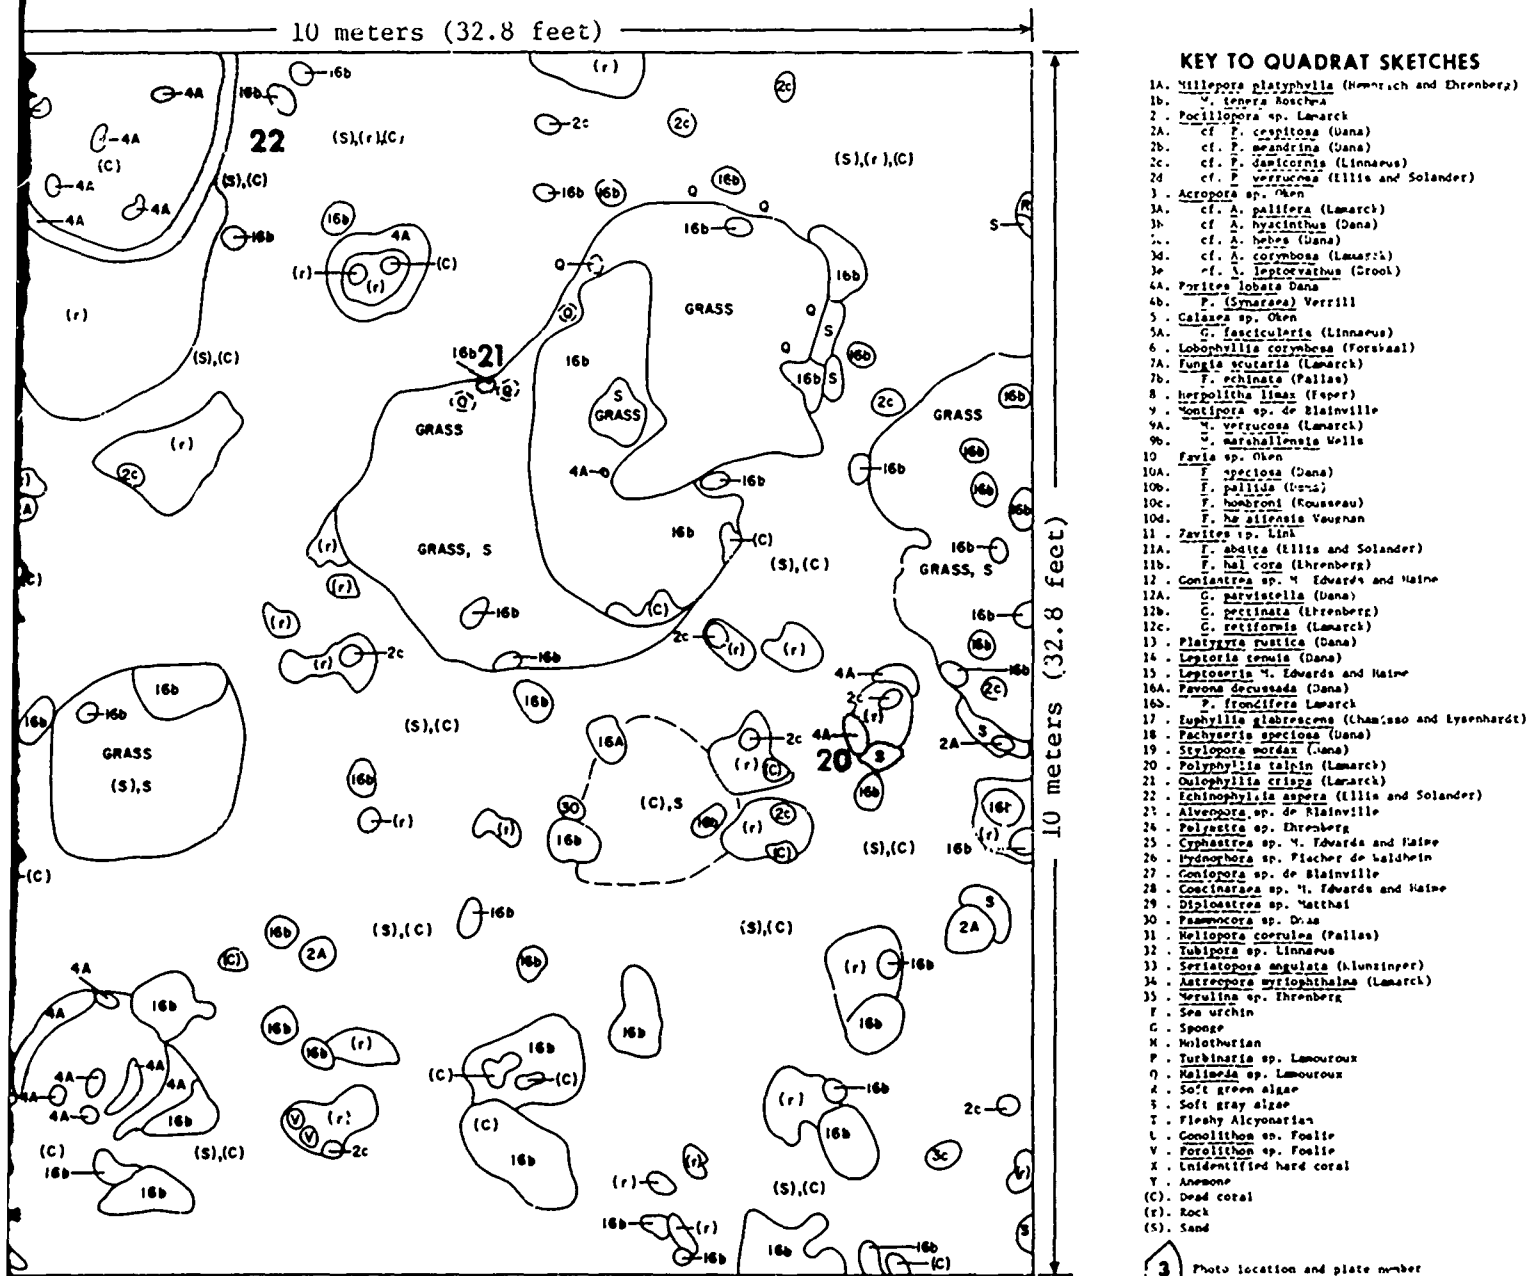
Figure 129. Species distribution chart, quadrat 6, Bangi Island.
